Catastrophic rig failures are frequently the result of detectable and avoidable flaws in worn or corroded metal chainplates. When in doubt, remove them for thorough inspection and possible replacement.

**Text and photographs  
by Dylan Bailey**

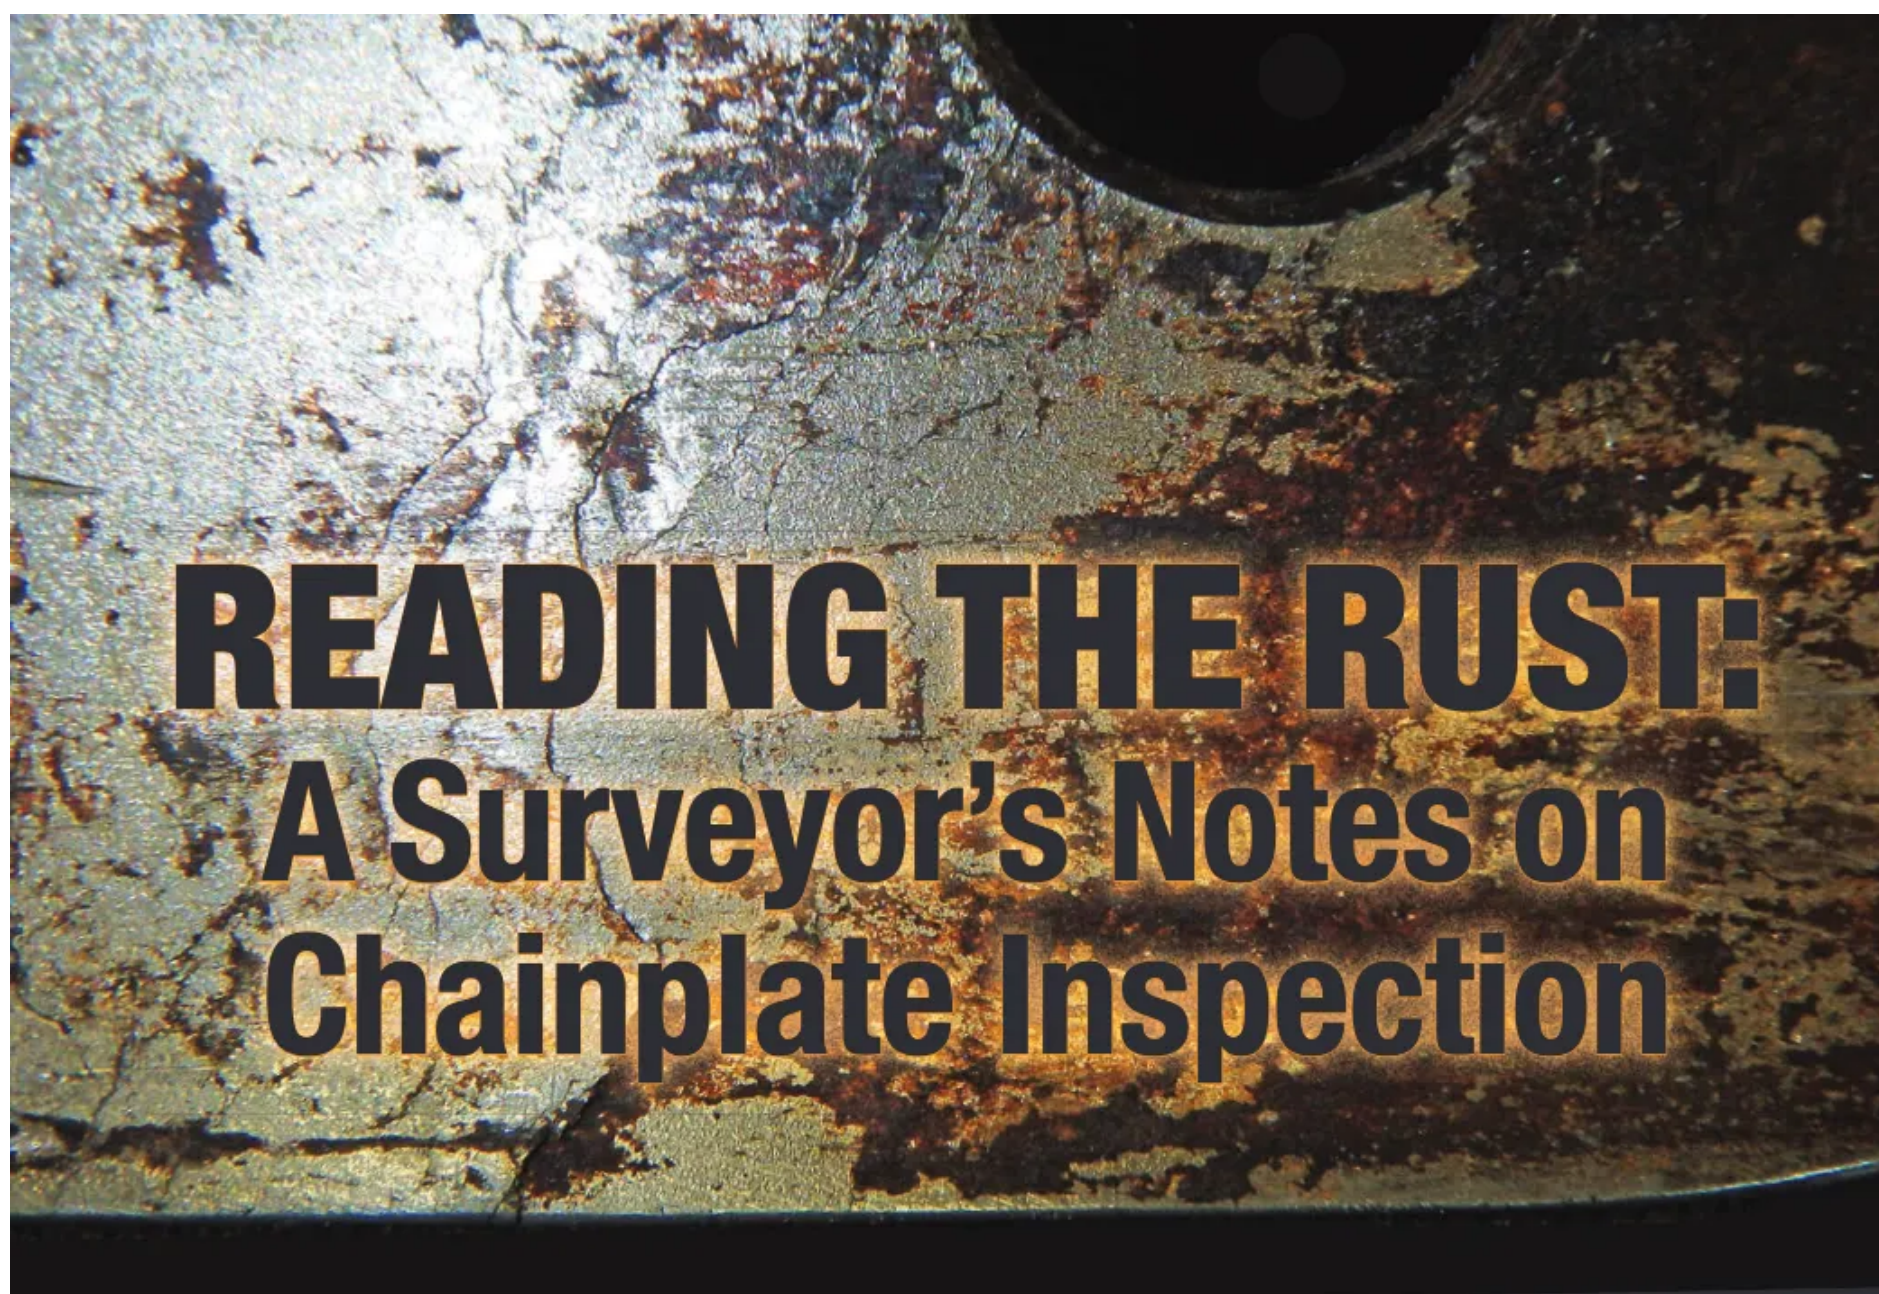
**Above**—Stainless steel is not flawless. Close inspection of aging chainplates reveals that deferred maintenance and hard use have allowed pitting and corrosion, which can weaken these essential rig attachment points.

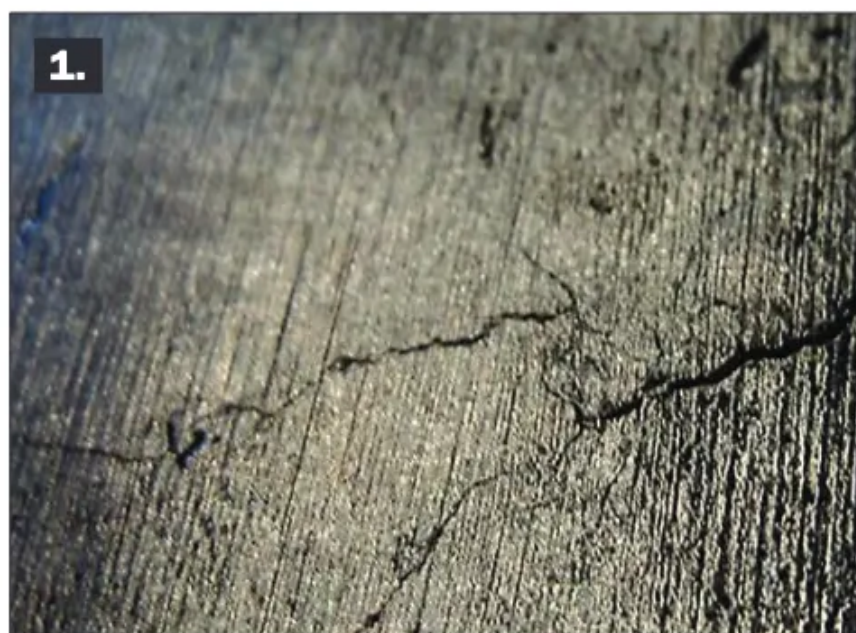
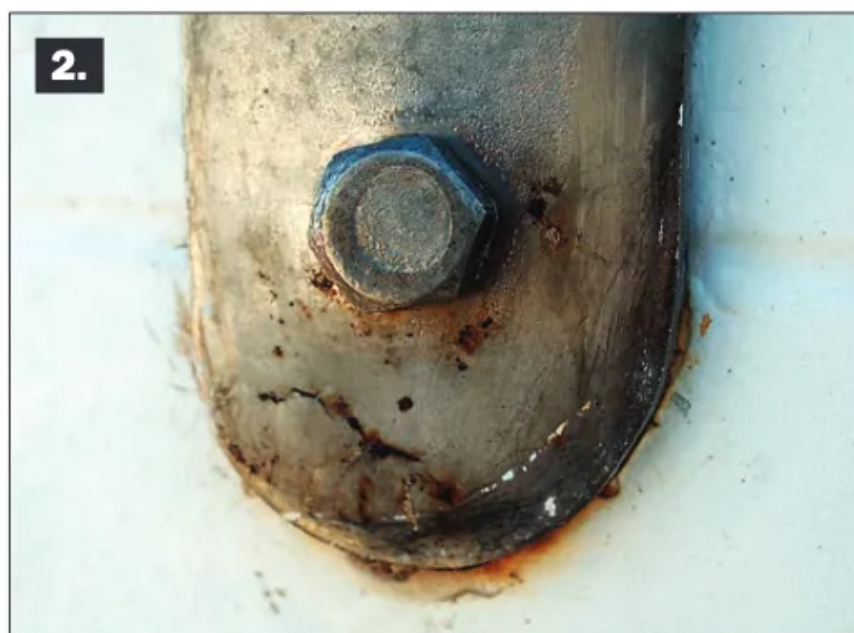
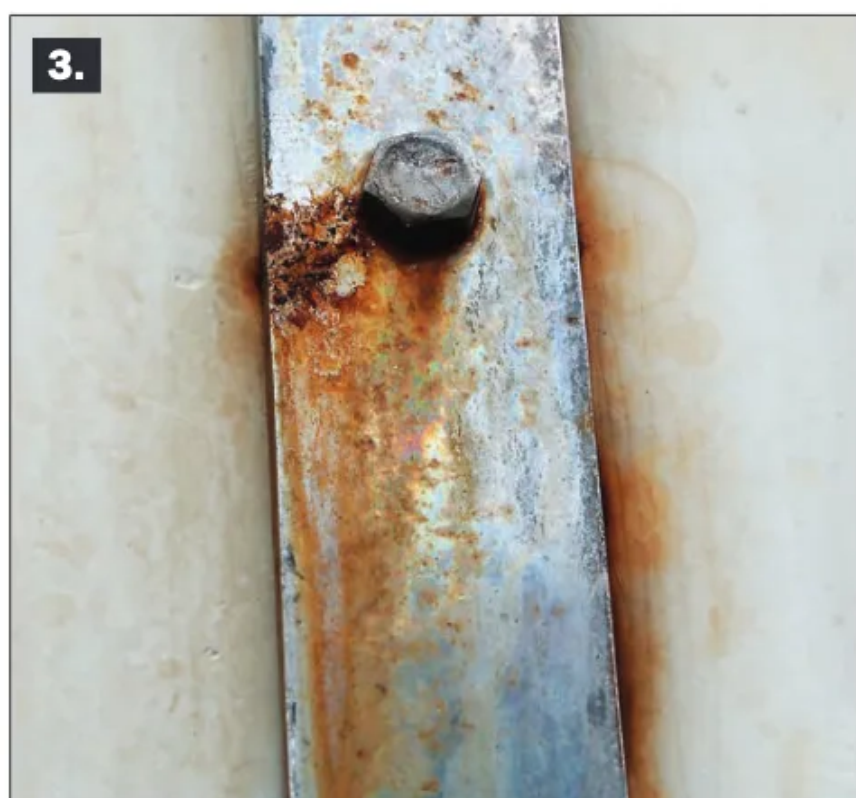
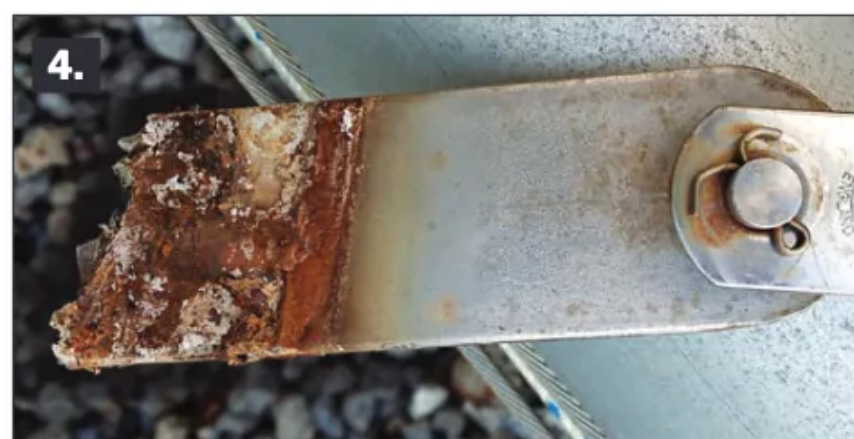
**1**—Take photographs with a camera set on macro and then magnify them on a computer screen to reveal cracks missed by a visual inspection in the field. **2**—Remove surface rust with a nylon scouring pad to show any underlying pits and cracks. **3**—Small cracks or rust blooms on the edges of a plate likely indicate greater problems between the stainless steel and the hull. **4**—A chainplate may appear sound at the rig attachment point but be entirely destroyed under the deck where moisture was held against it without oxygen.

**Visual.** The following inspection can be performed by riggers, surveyors, and boatyard staff. Start on deck and visually inspect all chainplates, regardless of the metal. On sailboats more than 20 years old, I frequently find cracks and corrosion on the chainplates above decks. Where you see rust, remove it with a nylon scouring pad (Scotch-Brite), and then inspect the chainplate closely through a magnifying glass for signs of crevice corrosion (pitting) and stress cracks. Take photos with a camera set on macro, and view the images later

on a computer screen or tablet. I have found cracks in an image magnified on a screen that I missed when I was on the boat. Pay close attention to exterior-mounted chainplates where they are fitted against the hull; corrosion will often develop there, concealed between the plate and the hull. Small cracks or rust blooms will be visible on the sides or edges of the chainplates.

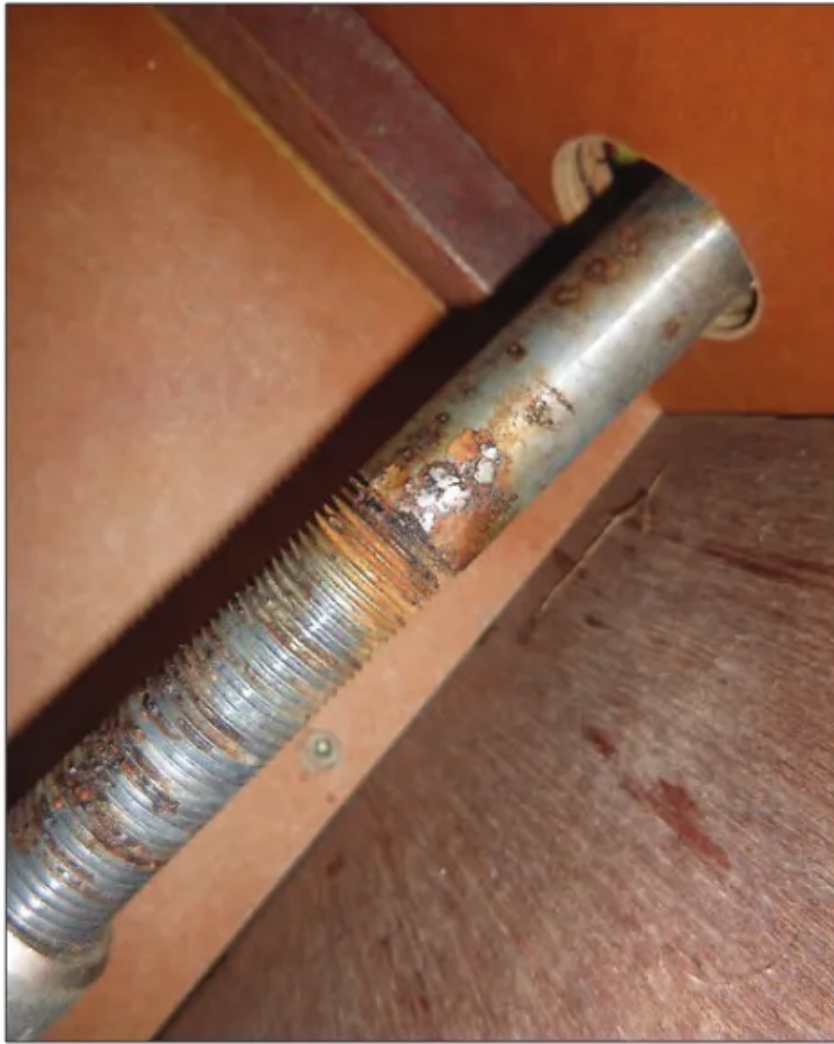
**Left**—For rod attachments, in addition to inspecting the plate that affixes to the hull, sight down the rod itself for signs of corrosion. **Above**—Dye-penetrant testing requires thorough cleaning of the metal before applying dye and developer to expose the smallest cracks and pits.

For U-bolts and rod attachments, look at the edges of the backing of the U-bolt chainplate for signs of corrosion. Sight down along the rod, keeping an eye out for crevice corrosion. Inspect the attachment point to the hull, and where the fitting is glassed into the hull, for signs of rust weeping and any cracks in the fiberglass.

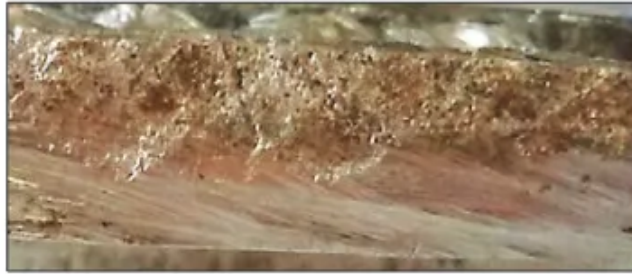
A hairline crack found on the back of this stainless steel chainplate led the author to cut the chainplate in half, revealing that more than 50% of its thickness had been severely depleted by corrosion.

should be imaged from the exterior, and the interior where possible. First, heat is applied to the interior of the boat, and the imaging is conducted on the exterior of the hull. Second, if you are able to gain clear access to the hull sides in way of the chainplates from the boat's interior, imaging can be conducted there by allowing the exterior of the hull to warm by solar loading. To do this, the boat should be placed at a north-south axis to allow both sides of the hull to warm from the sun as it travels through its arc. If thermal imaging detects anomalies indicating trapped moisture, the chainplate should be removed. Likewise, if signs of corrosion or cracks are sighted, then the chainplates will need to be removed. The photograph above shows an embedded chainplate with hairline cracks on the backside, where it was up against the hull. The chainplate was cut in half at one crack to show how much metal was depleted by corrosion.
